# Manhole Inspection Report

Date:	<b>04/05/2018</b>	Weather:		Coding:	<b>RZMACP</b>
MH#:	<b>M-507-003</b>	Owner:	<b>NA</b>	Len. Surveyed:	<b>7.8</b>
P.O.#:		Surveyor:	<b>John Kuglmaier</b>	Rim to Invert:	<b>8.2</b>
Customer:		Cert. #:	<b>U-1215-07002349</b>	Wall Material:	<b>Concrete (reinforced)</b>

Street:	<b>West of Delaware St. South of L/S 7.</b>	Project:	<b>Hobart, IN</b>
City:	<b>Hobart, IN</b>	GPS Northing:	<b>0.0</b>
Location:		GPS Easting:	<b>0.0</b>
Drain Area:	<b>Southwest</b>	GPS Accuracy:	<b>Nearest Meter</b>
Cover Shape:	<b>Circular</b>	Evidence of Surcharge:	<b>Yes</b>
Cover Size:	<b>22.5</b>	Potential for Runoff:	<b>None</b>
Comments:

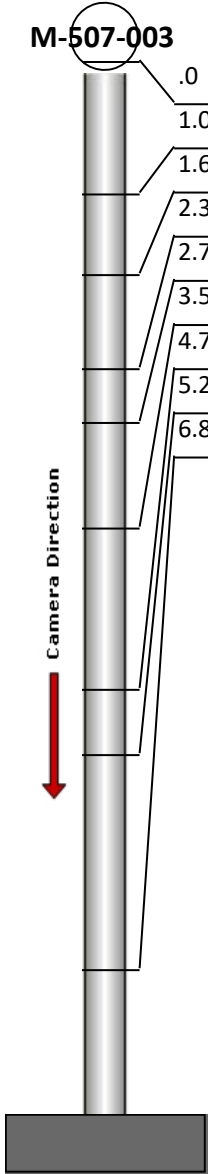
.0	MGP	General Photo	10	NA
	1.0	IS	Infil Stain	24	NA
	1.6	IS	Infil Stain	37	NA
	2.3	MGP	General Photo	52	NA
	2.7	IS	Infil Stain	67	NA
	3.5	IS	Infil Stain	80	NA
	4.7	IS	Infil Stain	94	NA
	5.2	DAZ	Deposits Attached Other	107	M 3
	6.8	MGO	General Observation	122	NA

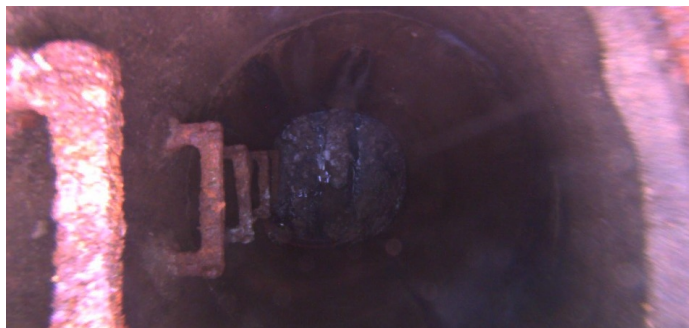
Code: **MGP**  
Description: **General Photo**

Distance (ft): **.0**  
Structural Grade: **0**  
O&M Grade: **0**  
Clock Start/From:  
Clock To:  
1st Value:  
2nd Value:  
Value Percent:  
Step: **NO**  
Remarks:

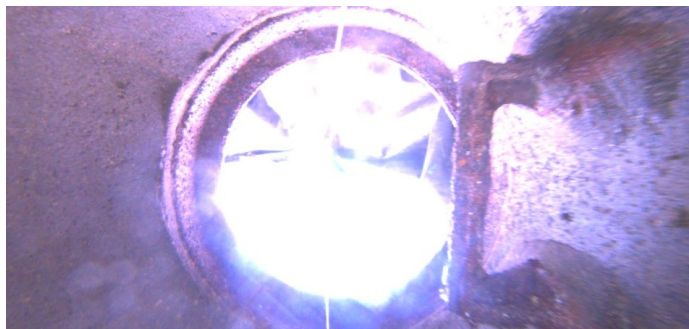
Code: **MGP**  
Description: **General Photo**

Distance (ft): **2.3**  
Structural Grade: **0**  
O&M Grade: **0**  
Clock Start/From:  
Clock To:  
1st Value:  
2nd Value:  
Value Percent:  
Step: **NO**  
Remarks:

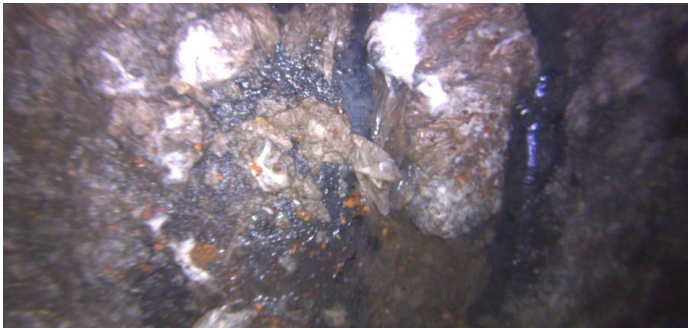
Code: **MGO**  
Description: **General Observation**

Distance (ft): **6.8**  
Structural Grade: **0**  
O&M Grade: **0**  
Clock Start/From:  
Clock To:  
1st Value:  
2nd Value:  
Value Percent:  
Step: **NO**  
Remarks: **Ins. Comp.**
