Manhole Inspection Report

Date:	04/05/2018	Weather:		Coding:	RZMACP
MH#:	M-507-004	Owner:	NA	Len. Surveyed:	13.2
P.O.#:		Surveyor:	John Kuglmaier	Rim to Invert:	13.3
Customer:		Cert. #:	U-1215-07002349	Wall Material:	Concrete (reinforced)

Street:	Delaware St. North of L/S.	Project:	Hobart, IN
City:	Hobart, IN	GPS Northing:	0.0
Location:		GPS Easting:	0.0
Drain Area:	Southwest	GPS Accuracy:	Nearest Meter
Cover Shape:	Circular	Evidence of Surcharge:	Yes
Cover Size:	22.5	Potential for Runoff:	None
Comments:

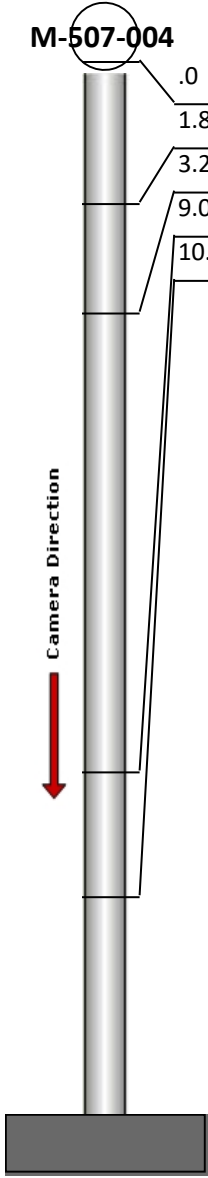
.0	MGP	General Photo	10	NA
	1.8	IS	Infil Stain	25	NA
	3.2	MGP	General Photo	42	NA
	9.0	DAZ	Deposits Attached Other	67	M 2
	10.6	MGO	General Observation	81	NA
