Manhole Inspection Report

Date:	04/07/2018	Weather:		Coding:	RZMACP
MH#:	M-507-014	Owner:	NA	Len. Surveyed:	8.4
P.O.#:		Surveyor:	John Kuglmaier	Rim to Invert:	8.6
Customer:		Cert. #:	U-1215-07002349	Wall Material:	Concrete (reinforced)

Street:	West of Delaware St. 265' North of	Project:	Hobart, IN
City:	Hobart, IN	GPS Northing:	0.0
Location:		GPS Easting:	0.0
Drain Area:	Southwest	GPS Accuracy:	Nearest Meter
Cover Shape:	Circular	Evidence of Surcharge:	Yes
Cover Size:	22.5	Potential for Runoff:	None
Comments:

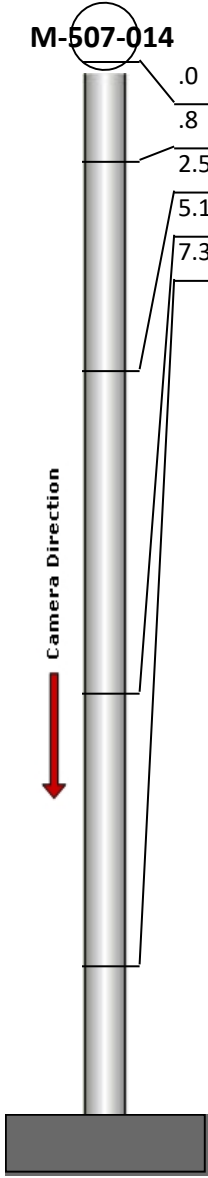
.0	MGP	General Photo	10	NA
	.8	IS	Infil Stain	23	NA
	2.5	MGP	General Photo	40	NA
	5.1	DAGS	Deposits Attached Grease	59	M 3
	7.3	MGO	General Observation	75	NA
