Manhole Inspection Report

Date:	03/28/2018	Weather:		Coding:	RZMACP
MH#:	M-507-023	Owner:	NA	Len. Surveyed:	8.6
P.O.#:		Surveyor:	John Kuglmaier	Rim to Invert:	9.1
Customer:		Cert. #:	U-1215-07002349	Wall Material:	Concrete (reinforced)

Street:	Csokasy Ln. 166' Northwest of Color	Project:	Hobart, IN
City:	Hobart, IN	GPS Northing:	0.0
Location:		GPS Easting:	0.0
Drain Area:	Southwest	GPS Accuracy:	Nearest Meter
Cover Shape:	Circular	Evidence of Surcharge:	Yes
Cover Size:	22.5	Potential for Runoff:	None
Comments:

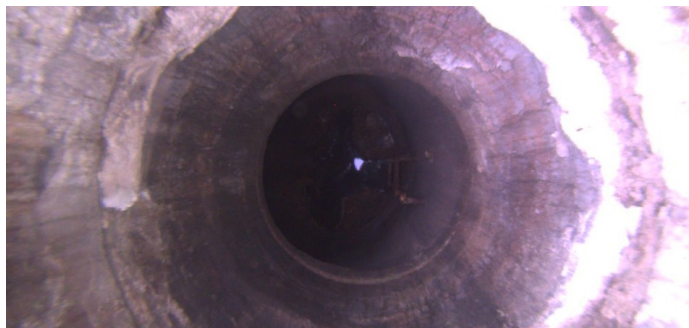
Code: **MGP**
Description: **General Photo**

Distance (ft): **.0**
Structural Grade: **0**
O&M Grade: **0**
Clock Start/From:
Clock To:
1st Value:
2nd Value:
Value Percent:
Step: **NO**
Remarks:

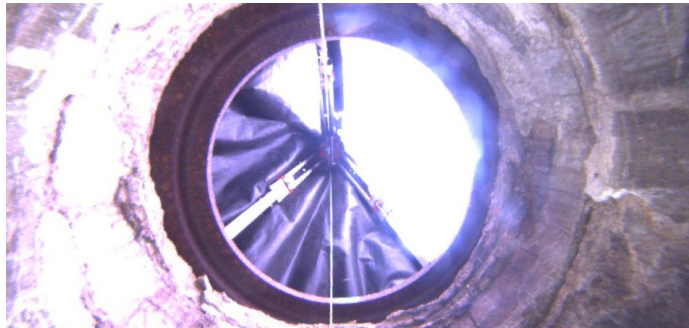
Code: **MGP**
Description: **General Photo**

Distance (ft): **2.2**
Structural Grade: **0**
O&M Grade: **0**
Clock Start/From:
Clock To:
1st Value:
2nd Value:
Value Percent:
Step: **NO**
Remarks:
