# Manhole Inspection Report

Date:	<b>04/26/2018</b>	Weather:		Coding:	<b>RZMACP</b>
MH#:	<b>M-507-028</b>	Owner:	<b>NA</b>	Len. Surveyed:	<b>5.1</b>
P.O.#:		Surveyor:	<b>Jen Costello</b>	Rim to Invert:	<b>5.6</b>
Customer:		Cert. #:	<b>U-907-5518</b>	Wall Material:	<b>Brick</b>

Street:	<b>Dekalb St. and 10th Pl. to the South.</b>	Project:	<b>Hobart, IN</b>
City:	<b>Hobart, IN</b>	GPS Northing:	<b>2900446.382</b>
Location:		GPS Easting:	<b>2900446.382</b>
Drain Area:	<b>Southwest</b>	GPS Accuracy:	<b>Sub-Meter</b>
Cover Shape:	<b>Circular</b>	Evidence of Surcharge:	<b>No</b>
Cover Size:	<b>22.5</b>	Potential for Runoff:	<b>None</b>
Comments:

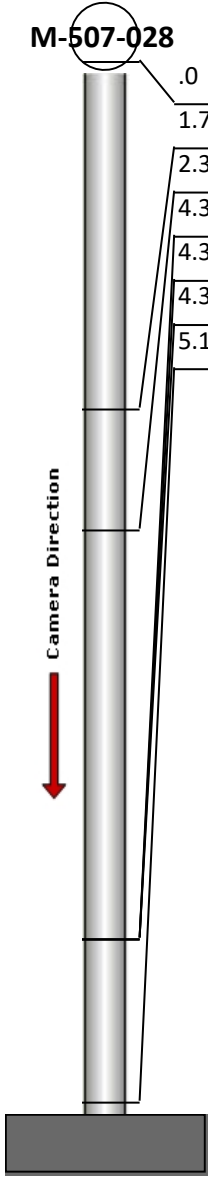
.0	MGO	General Observation	10	NA
	1.7	MGO	General Observation	27	NA
	2.3	FM	Fracture Multiple	43	S 4
	4.3	B	Broken	60	S 3
	4.3	SAP	Surface Aggregate Projecting	71	S 3
	4.3	OBZ	Obstacle Other	82	M 2
	5.1	MGO	General Observation	95	NA
