Manhole Inspection Report

Date:	03/27/2018	Weather:		Coding:	RZMACP
MH#:	M-507-029	Owner:	NA	Len. Surveyed:	8.8
P.O.#:		Surveyor:	John Kuglmaier	Rim to Invert:	9.3
Customer:		Cert. #:	U-1215-07002349	Wall Material:	Concrete (reinforced)

Street:	Northwest of Dekalb Ct. 188' South	Project:	Hobart, IN
City:	Hobart, IN	GPS Northing:	0.0
Location:		GPS Easting:	0.0
Drain Area:	Southwest	GPS Accuracy:	Nearest Meter
Cover Shape:	Circular	Evidence of Surcharge:	No
Cover Size:	22.5	Potential for Runoff:	None
Comments:

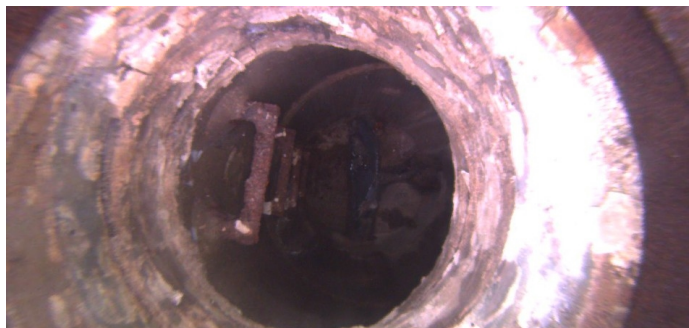
Code: **MGP**
Description: **General Photo**

Distance (ft): **.0**
Structural Grade: **0**
O&M Grade: **0**
Clock Start/From:
Clock To:
1st Value:
2nd Value:
Value Percent:
Step: **NO**
Remarks:

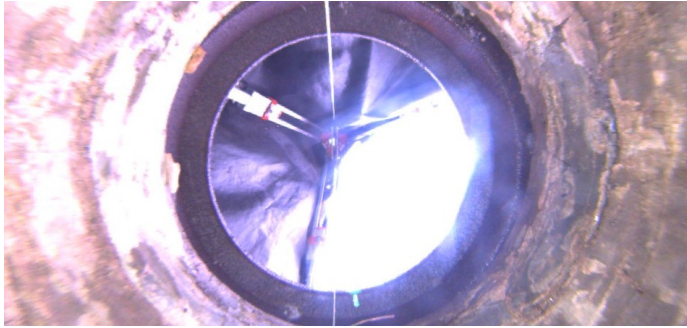
Code: **MGP**
Description: **General Photo**

Distance (ft): **2.6**
Structural Grade: **0**
O&M Grade: **0**
Clock Start/From:
Clock To:
1st Value:
2nd Value:
Value Percent:
Step: **NO**
Remarks:
