Manhole Inspection Report

Date:	04/07/2018	Weather:		Coding:	RZMACP
MH#:	M-507-030	Owner:	NA	Len. Surveyed:	7.4
P.O.#:		Surveyor:	John Kuglmaier	Rim to Invert:	8.0
Customer:		Cert. #:	U-1215-07002349	Wall Material:	Concrete (reinforced)

Street:	South of Decatur St. 78' Southwest	Project:	Hobart, IN
City:	Hobart, IN	GPS Northing:	0.0
Location:		GPS Easting:	0.0
Drain Area:	Southwest	GPS Accuracy:	Nearest Meter
Cover Shape:	Circular	Evidence of Surcharge:	Yes
Cover Size:	22.5	Potential for Runoff:	None
Comments:

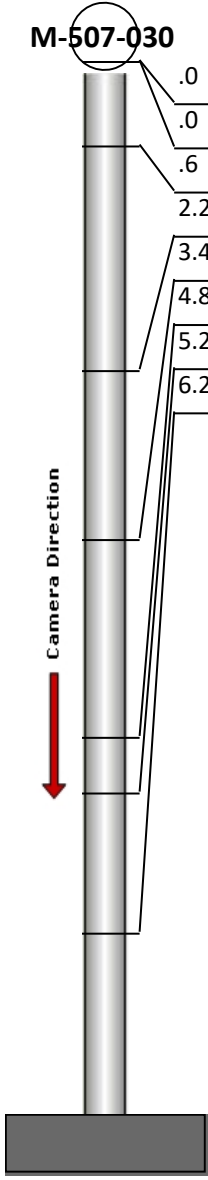
.0	MGP	General Photo	10	NA
	.0	RFJ	Roots Fine Joint	22	M 1
	.6	IS	Infil Stain	35	NA
	2.2	MGP	General Photo	52	NA
	3.4	IS	Infil Stain	68	NA
	4.8	DAZ	Deposits Attached Other	82	M 2
	5.2	OBZ	Obstacle Other	94	M 2
	6.2	MGO	General Observation	108	NA
