Manhole Inspection Report

Date:	04/25/2018	Weather:		Coding:	RZMACP
MH#:	M-507-038A	Owner:	NA	Len. Surveyed:	5.7
P.O.#:		Surveyor:	Jen Costello	Rim to Invert:	7.0
Customer:	8.7	Cert. #:	U-907-5518	Wall Material:	Concrete (reinforced)

Street:	10th St. Wisconsin St	Project:	Hobart, IN
City:	Hobart, IN	GPS Northing:	0.0
Location:		GPS Easting:	0.0
Drain Area:	Southwest	GPS Accuracy:	Nearest Meter
Cover Shape:	Circular	Evidence of Surcharge:	No
Cover Size:	22.5	Potential for Runoff:	None
Comments:

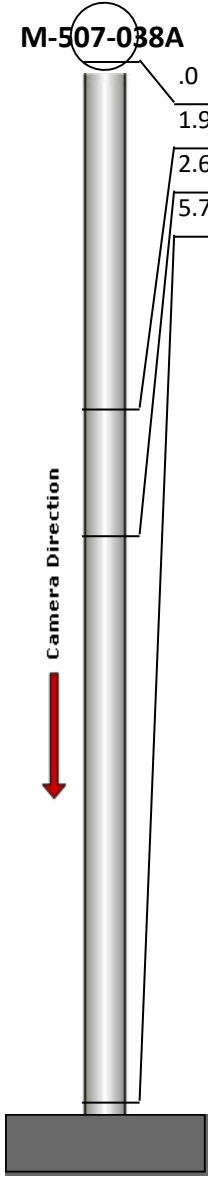
.0	MGO	General Observation	10	NA
	1.9	IS	Infil Stain	25	NA
	2.6	MGO	General Observation	40	NA
	5.7	MGO	General Observation	59	NA
