Manhole Inspection Report

Date:	03/28/2018	Weather:		Coding:	RZMACP
MH#:	M-507-061	Owner:	NA	Len. Surveyed:	3.3
P.O.#:		Surveyor:	John Kuglmaier	Rim to Invert:	3.7
Customer:		Cert. #:	U-1215-07002349	Wall Material:	Concrete (reinforced)

Street:	13th Pl. 402' East of Virginia St.	Project:	Hobart, IN
City:	Hobart, IN	GPS Northing:	0.0
Location:		GPS Easting:	0.0
Drain Area:	Southwest	GPS Accuracy:	Nearest Meter
Cover Shape:	Circular	Evidence of Surcharge:	No
Cover Size:	22.5	Potential for Runoff:	None
Comments:

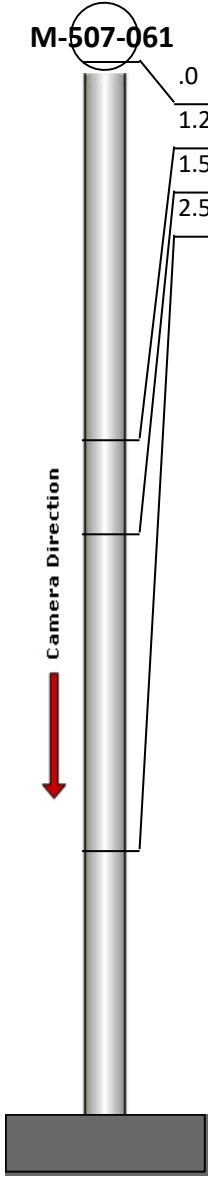
.0	MGP	General Photo	10	NA
	1.2	DAZ	Deposits Attached Other	24	M 2
	1.5	MGP	General Photo	38	NA
	2.5	MGO	General Observation	54	NA
