Manhole Inspection Report

Date:	04/25/2018	Weather:		Coding:	RZMACP
MH#:	M-507-075	Owner:	NA	Len. Surveyed:	5.7
P.O.#:		Surveyor:	John Kuglmaier	Rim to Invert:	5.9
Customer:		Cert. #:	U-1215-07002349	Wall Material:	Concrete (reinforced)

Street:	North of 11th St. 338' East of Colora	Project:	Hobart, IN
City:	Hobart, IN	GPS Northing:	2901238.539
Location:		GPS Easting:	2901238.539
Drain Area:	Southwest	GPS Accuracy:	Sub-Meter
Cover Shape:	Circular	Evidence of Surcharge:	Yes
Cover Size:	22.5	Potential for Runoff:	None
Comments:

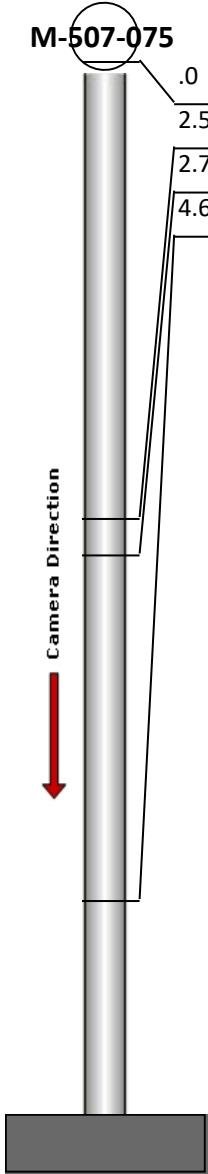
.0	MGP	General Photo	10	NA
	2.5	DSF	Deposits Settled Fine	26	M 3
	2.7	MGP	General Photo	40	NA
	4.6	MGO	General Observation	58	NA
