Manhole Inspection Report

Date:	04/24/2018	Weather:		Coding:	RZMACP
MH#:	M-507-083	Owner:	NA	Len. Surveyed:	5.2
P.O.#:		Surveyor:	John Kuglmaier	Rim to Invert:	5.4
Customer:		Cert. #:	U-1215-07002349	Wall Material:	Concrete (reinforced)

Street:	On 10th Pl. 171' West of Colorado St	Project:	Hobart, IN
City:	Hobart, IN	GPS Northing:	2900612.946
Location:		GPS Easting:	2900612.946
Drain Area:	Southwest	GPS Accuracy:	Sub-Meter
Cover Shape:	Circular	Evidence of Surcharge:	No
Cover Size:	22.5	Potential for Runoff:	None
Comments:

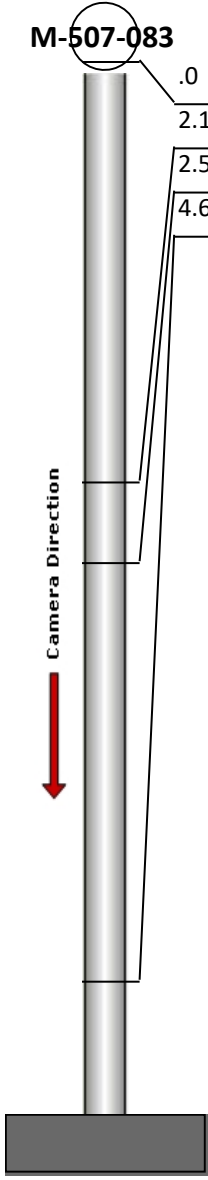
.0	MGP	General Photo	10	NA
	2.1	MGP	General Photo	28	NA
	2.5	DAZ	Deposits Attached Other	43	M 2
	4.6	MGO	General Observation	58	NA
