Manhole Inspection Report

Date:	04/24/2018	Weather:		Coding:	RZMACP
MH#:	M-507-084	Owner:	NA	Len. Surveyed:	6.0
P.O.#:		Surveyor:	John Kuglmaier	Rim to Invert:	6.5
Customer:		Cert. #:	U-1215-07002349	Wall Material:	Concrete (reinforced)

Street:	10th Pl. and Colorado St.	Project:	Hobart, IN
City:	Hobart, IN	GPS Northing:	41.52098846
Location:		GPS Easting:	-87.27307129
Drain Area:	Southwest	GPS Accuracy:	Nearest Meter
Cover Shape:	Circular	Evidence of Surcharge:	No
Cover Size:	22.5	Potential for Runoff:	None
Comments:

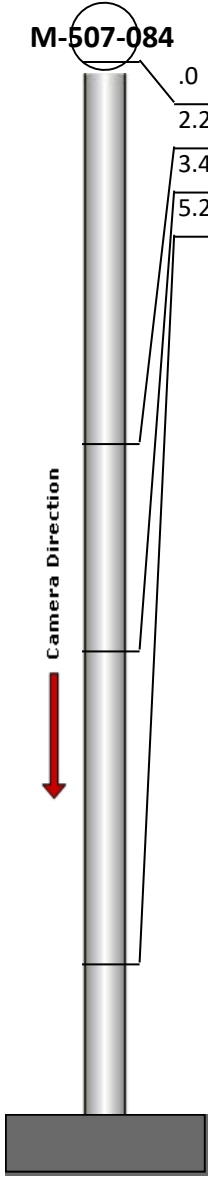
.0	MGP	General Photo	10	NA
	2.2	MGP	General Photo	28	NA
	3.4	DSF	Deposits Settled Fine	44	M 2
	5.2	MGO	General Observation	60	NA
