Manhole Inspection Report

Date:	04/05/2018	Weather:		Coding:	RZMACP
MH#:	M-508-001	Owner:	NA	Len. Surveyed:	5.7
P.O.#:		Surveyor:	John Kuglmaier	Rim to Invert:	6.3
Customer:		Cert. #:	U-1215-07002349	Wall Material:	Concrete (reinforced)

Street:	14th St. and Wisconsin St.	Project:	Hobart, IN
City:	Hobart, IN	GPS Northing:	0.0
Location:		GPS Easting:	0.0
Drain Area:	Southwest	GPS Accuracy:	Nearest Meter
Cover Shape:	Circular	Evidence of Surcharge:	No
Cover Size:	22.5	Potential for Runoff:	None
Comments:

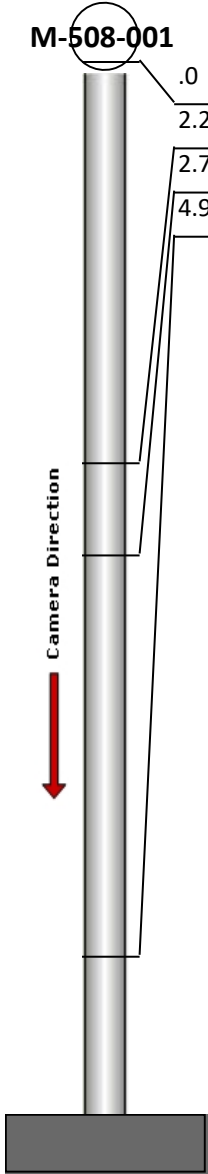
.0	MGP	General Photo	10	NA
	2.2	MGP	General Photo	28	NA
	2.7	DSF	Deposits Settled Fine	43	M 2
	4.9	MGO	General Observation	59	NA
