Manhole Inspection Report

Date:	04/12/2018	Weather:		Coding:	RZMACP
MH#:	M-603-021	Owner:	NA	Len. Surveyed:	3.5
P.O.#:		Surveyor:	John Kuglmaier	Rim to Invert:	3.8
Customer:		Cert. #:	U-1215-07002349	Wall Material:	Concrete (reinforced)

Street:	37th Ave. East of Wisconsin St.	Project:	Hobart, IN
City:	Hobart, IN	GPS Northing:	2902394.929
Location:		GPS Easting:	2902394.929
Drain Area:	Northwest	GPS Accuracy:	Sub-Meter
Cover Shape:	Circular	Evidence of Surcharge:	No
Cover Size:	23.0	Potential for Runoff:	None
Comments:

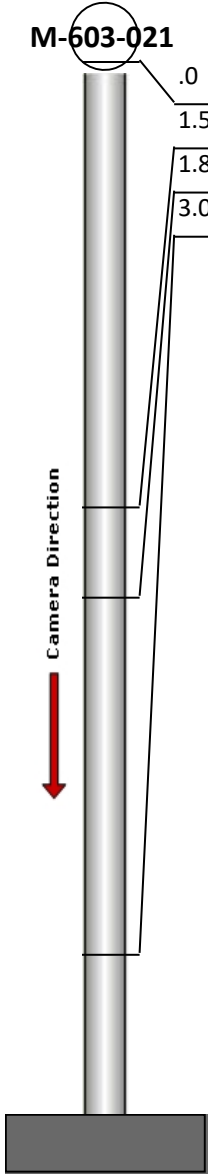
.0	MGP	General Photo	10	NA
	1.5	DSF	Deposits Settled Fine	24	M 2
	1.8	MGP	General Photo	39	NA
	3.0	MGO	General Observation	54	NA
