Manhole Inspection Report

Date:	04/11/2018	Weather:		Coding:	RZMACP
MH#:	M-603-025	Owner:	NA	Len. Surveyed:	8.2
P.O.#:		Surveyor:	John Kuglmaier	Rim to Invert:	10.0
Customer:		Cert. #:	U-1215-07002349	Wall Material:	Concrete (reinforced)

Street:	453' Southwest of 40th Pl. and Was	Project:	Hobart, IN
City:	Hobart, IN	GPS Northing:	2902620.277
Location:		GPS Easting:	2902620.277
Drain Area:	Northwest	GPS Accuracy:	Sub-Meter
Cover Shape:	Circular	Evidence of Surcharge:	No
Cover Size:	23.0	Potential for Runoff:	None
Comments:

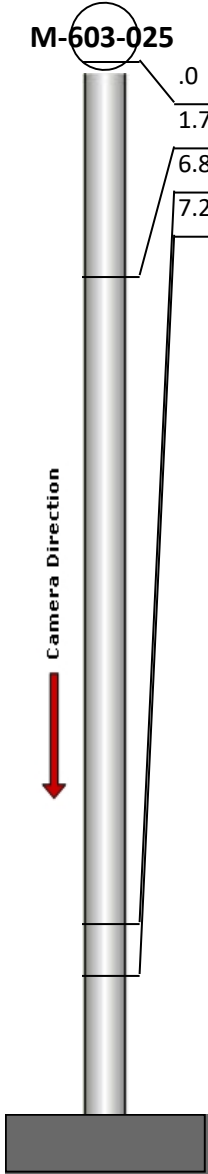
.0	MGP	General Photo	10	NA
	1.7	MGP	General Photo	27	NA
	6.8	DSF	Deposits Settled Fine	51	M 3
	7.2	MGO	General Observation	64	NA
