Manhole Inspection Report

Date:	04/11/2018	Weather:		Coding:	RZMACP
MH#:	M-603-026	Owner:	NA	Len. Surveyed:	5.3
P.O.#:		Surveyor:	John Kuglmaier	Rim to Invert:	6.5
Customer:		Cert. #:	U-1215-07002349	Wall Material:	Concrete (reinforced)

Street:	531' West of 40th Pl. and Washingto	Project:	Hobart, IN
City:	Hobart, IN	GPS Northing:	2902736.649
Location:		GPS Easting:	2902736.649
Drain Area:	Northwest	GPS Accuracy:	Sub-Meter
Cover Shape:	Circular	Evidence of Surcharge:	Yes
Cover Size:	23.0	Potential for Runoff:	None
Comments:

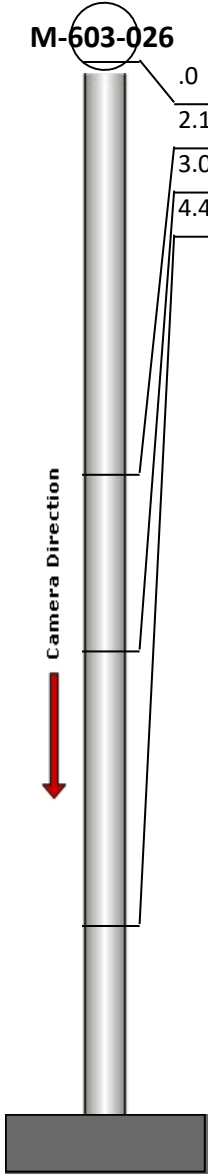
.0	MGP	General Photo	10	NA
	2.1	MGP	General Photo	28	NA
	3.0	DSF	Deposits Settled Fine	43	M 2
	4.4	MGO	General Observation	57	NA
