# Manhole Inspection Report

Date:	<b>04/11/2018</b>	Weather:		Coding:	<b>RZMACP</b>
MH#:	<b>M-603-028</b>	Owner:	<b>NA</b>	Len. Surveyed:	<b>4.9</b>
P.O.#:		Surveyor:	<b>John Kuglmaier</b>	Rim to Invert:	<b>6.0</b>
Customer:		Cert. #:	<b>U-1215-07002349</b>	Wall Material:	<b>Concrete (reinforced)</b>

Street:	<b>313' Northeast of 40th Pl. and Wash</b>	Project:	<b>Hobart, IN</b>
City:	<b>Hobart, IN</b>	GPS Northing:	<b>0.0</b>
Location:		GPS Easting:	<b>0.0</b>
Drain Area:	<b>Northwest</b>	GPS Accuracy:	<b>Nearest Meter</b>
Cover Shape:	<b>Circular</b>	Evidence of Surcharge:	<b>Yes</b>
Cover Size:	<b>23.0</b>	Potential for Runoff:	<b>None</b>
Comments:

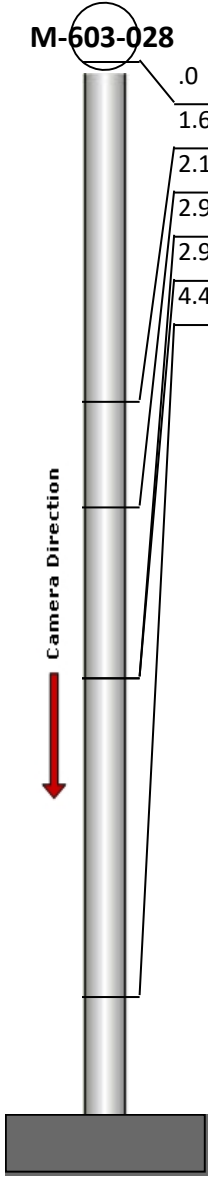
.0	MGP	General Photo	10	NA
	1.6	IS	Infil Stain	25	NA
	2.1	MGP	General Photo	40	NA
	2.9	DAZ	Deposits Attached Other	55	M 2
	2.9	IS	Infil Stain	67	NA
	4.4	MGO	General Observation	81	NA
