Manhole Inspection Report

Date:	04/08/2018	Weather:		Coding:	RZMACP
MH#:	M-603-033	Owner:	NA	Len. Surveyed:	6.0
P.O.#:		Surveyor:	John Kuglmaier	Rim to Invert:	7.5
Customer:		Cert. #:	U-1215-07002349	Wall Material:	Concrete (reinforced)

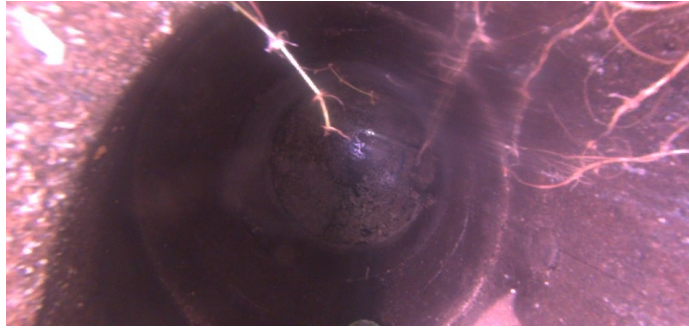
Code: **RFJ**
Description: **Roots Fine Joint**

Distance (ft): **.0**
Structural Grade: **0**
O&M Grade: **1**
Clock Start/From: **12**
Clock To: **3**
1st Value:
2nd Value:
Value Percent:
Step: **NO**
Remarks:

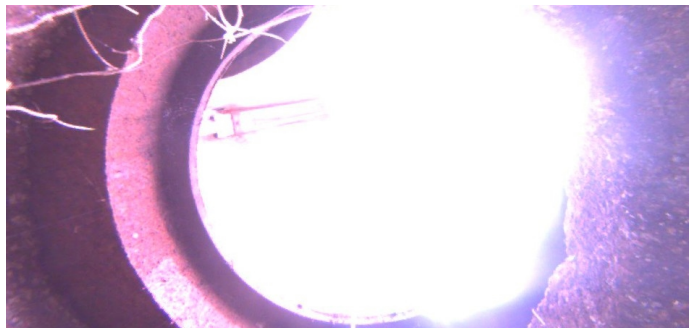
Code: **MGP**
Description: **General Photo**

Distance (ft): **.0**
Structural Grade: **0**
O&M Grade: **0**
Clock Start/From:
Clock To:
1st Value:
2nd Value:
Value Percent:
Step: **NO**
Remarks:
