# Manhole Inspection Report

Date:	<b>04/29/2018</b>	Weather:		Coding:	<b>RZMACP</b>
MH#:	<b>M-604-000</b>	Owner:	<b>NA</b>	Len. Surveyed:	<b>6.4</b>
P.O.#:		Surveyor:	<b>Jen Costello</b>	Rim to Invert:	<b>7.1</b>
Customer:		Cert. #:	<b>U-907-5518</b>	Wall Material:	<b>Brick</b>

Street:	<b>West Side of Lake Park Ave North of</b>	Project:	<b>Hobart, IN</b>
City:	<b>Hobart, IN</b>	GPS Northing:	<b>2904433.106</b>
Location:		GPS Easting:	<b>2904433.106</b>
Drain Area:	<b>North</b>	GPS Accuracy:	<b>Sub-Meter</b>
Cover Shape:	<b>Circular</b>	Evidence of Surcharge:	<b>No</b>
Cover Size:	<b>22.5</b>	Potential for Runoff:	<b>None</b>
Comments:

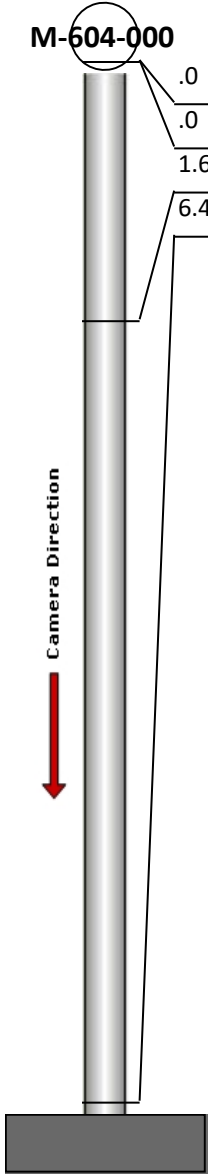
.0	MGO	General Observation	10	NA
	.0	DB	Displaced Brick	22	S 3
	1.6	MGP	General Photo	38	NA
	6.4	MGO	General Observation	61	NA
