# Manhole Inspection Report

Date:	05/01/2018	Weather:		Coding:	RZMACP
MH#:	M-604-001	Owner:	NA	Len. Surveyed:	4.5
P.O.#:		Surveyor:	Jen Costello	Rim to Invert:	4.8
Customer:		Cert. #:	U-907-5518	Wall Material:	Concrete (reinforced)

Street:	Intersection of Lake Park Ave. and CI	Project:	Hobart, IN
City:	Hobart, IN	GPS Northing:	41.5362854
Location:		GPS Easting:	-87.25980377
Drain Area:	West	GPS Accuracy:	Nearest Meter
Cover Shape:	Circular	Evidence of Surcharge:	No
Cover Size:	22.5	Potential for Runoff:	None
Comments:

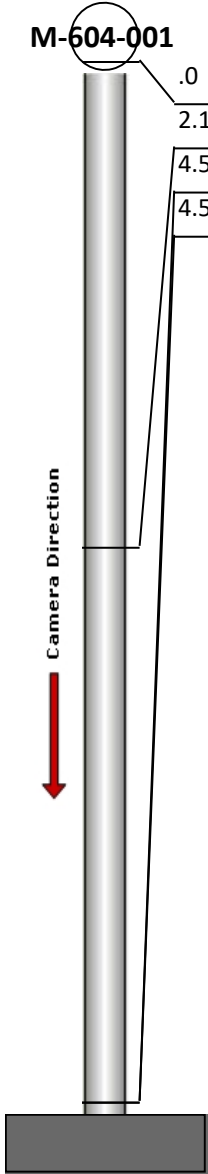
M-604-001				
	.0	MGP	General Photo	10	NA
	2.1	MGO	General Observation	28	NA
	4.5	DSZ	Deposits Settled Other	46	M 4
	4.5	MGO	General Observation	57	NA
