Manhole Inspection Report

Date:	05/01/2018	Weather:		Coding:	RZMACP
MH#:	M-604-002	Owner:	NA	Len. Surveyed:	5.6
P.O.#:		Surveyor:	Jen Costello	Rim to Invert:	5.8
Customer:		Cert. #:	U-907-5518	Wall Material:	Concrete (reinforced)

Street:	Cleveland Ave. 98' East of Beverly Ln	Project:	Hobart, IN
City:	Hobart, IN	GPS Northing:	41.53626251
Location:		GPS Easting:	-87.26044464
Drain Area:	West	GPS Accuracy:	Nearest Meter
Cover Shape:	Circular	Evidence of Surcharge:	No
Cover Size:	22.5	Potential for Runoff:	None
Comments:

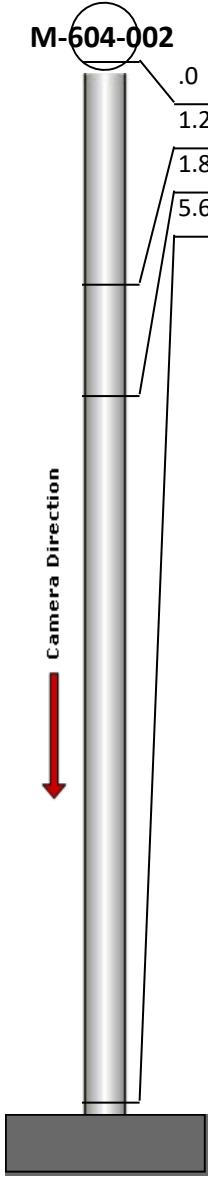
.0	MGP	General Photo	10	NA
	1.2	CL	Crack Longitudinal	24	S 2
	1.8	MGO	General Observation	39	NA
	5.6	MGO	General Observation	59	NA
