Manhole Inspection Report

Date:	05/01/2018	Weather:		Coding:	RZMACP
MH#:	M-604-004	Owner:	NA	Len. Surveyed:	7.0
P.O.#:		Surveyor:	Jen Costello	Rim to Invert:	7.5
Customer:		Cert. #:	U-907-5518	Wall Material:	Concrete (reinforced)

Street:	Intersection of Cleveland Ave. and	Project:	Hobart, IN
City:	Hobart, IN	GPS Northing:	41.53628159
Location:		GPS Easting:	-87.26189423
Drain Area:	West	GPS Accuracy:	Nearest Meter
Cover Shape:	Circular	Evidence of Surcharge:	No
Cover Size:	22.5	Potential for Runoff:	None
Comments:

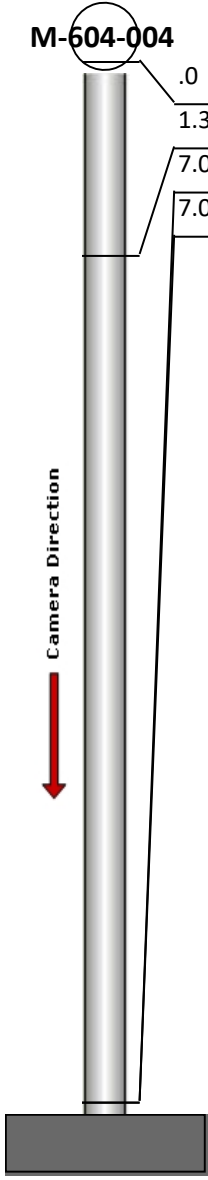
M-604-004				
	.0	MGO	General Observation	10	NA
	1.3	MGO	General Observation	26	NA
	7.0	B	Broken	50	S 3
	7.0	MGO	General Observation	60	NA
