Manhole Inspection Report

Date:	05/01/2018	Weather:		Coding:	RZMACP
MH#:	M-604-004	Owner:	NA	Len. Surveyed:	6.1
P.O.#:		Surveyor:	Jen Costello	Rim to Invert:	6.7
Customer:		Cert. #:	U-907-5518	Wall Material:	Brick

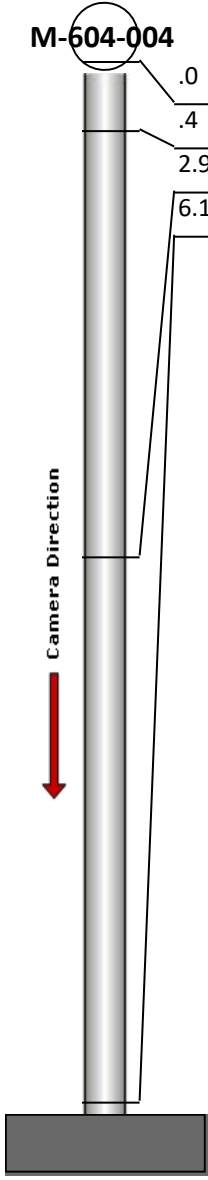
.0	MGP	General Photo	10	NA
	.4	FM	Fracture Multiple	23	S 4
	2.9	MGO	General Observation	41	NA
	6.1	MGO	General Observation	61	NA
