Manhole Inspection Report

Date:	04/28/2018	Weather:		Coding:	RZMACP
MH#:	M-604-010	Owner:	NA	Len. Surveyed:	18.6
P.O.#:		Surveyor:	Jen Costello	Rim to Invert:	18.3
Customer:		Cert. #:	U-907-5518	Wall Material:	Concrete (reinforced)

Street:	Old Ridge Rd. and Lake Park Ave. To	Project:	Hobart, IN
City:	Hobart, IN	GPS Northing:	41.53735352
Location:		GPS Easting:	-87.25989532
Drain Area:	Northwest	GPS Accuracy:	Nearest Meter
Cover Shape:	Circular	Evidence of Surcharge:	No
Cover Size:	22.5	Potential for Runoff:	None
Comments:

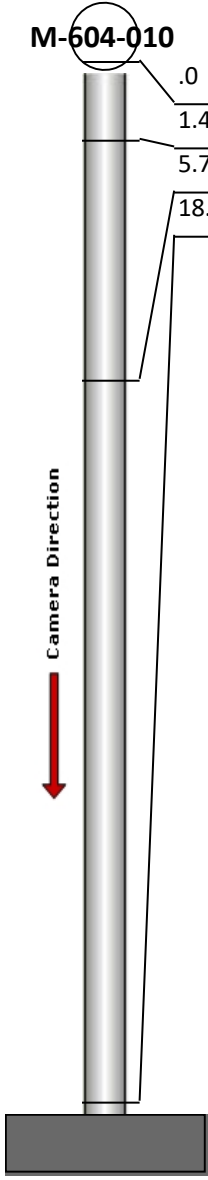
.0	MGO	General Observation	10	NA
	1.4	MGP	General Photo	26	NA
	5.7	IW	Infil Weeper	48	M 2
	18.6	MGO	General Observation	85	NA
