Manhole Inspection Report

Date:	05/14/2018	Weather:		Coding:	RZMACP
MH#:	M-604-030	Owner:	NA	Len. Surveyed:	6.0
P.O.#:		Surveyor:	Jen Costello	Rim to Invert:	6.4
Customer:		Cert. #:	U-907-5518	Wall Material:	Concrete (reinforced)

Street:	Intersection of Lake Park Ave. and L	Project:	Hobart, IN
City:	Hobart, IN	GPS Northing:	2904421.601
Location:		GPS Easting:	2904421.601
Drain Area:	North	GPS Accuracy:	Sub-Meter
Cover Shape:	Circular	Evidence of Surcharge:	No
Cover Size:	22.5	Potential for Runoff:	None
Comments:

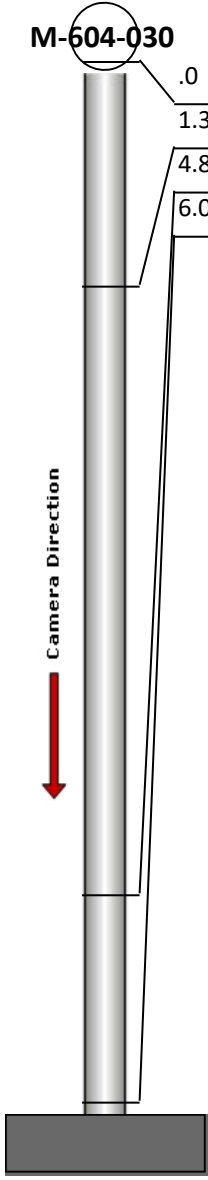
.0	MGP	General Photo	10	NA
	1.3	MGO	General Observation	26	NA
	4.8	DSZ	Deposits Settled Other	46	M 2
	6.0	MGO	General Observation	60	NA
