Manhole Inspection Report

Date:	05/14/2018	Weather:		Coding:	RZMACP
MH#:	M-604-034	Owner:	NA	Len. Surveyed:	3.7
P.O.#:		Surveyor:	Jen Costello	Rim to Invert:	4.0
Customer:		Cert. #:	U-907-5518	Wall Material:	Concrete (reinforced)

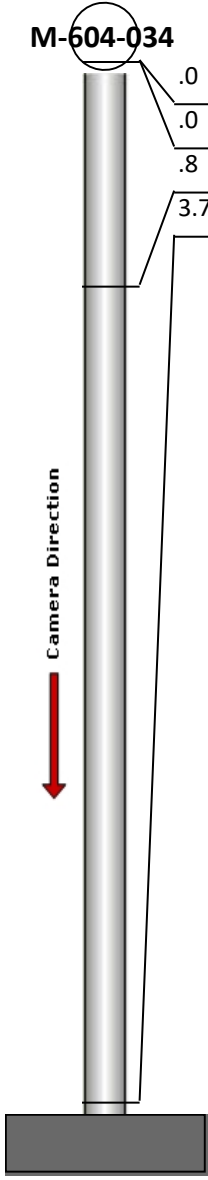
M-604-034				
	.0	MGP	General Photo	10	NA
	.0	SAP	Surface Aggregate Projecting	22	S 3
	.8	MGO	General Observation	36	NA
	3.7	MGO	General Observation	55	NA
