Manhole Inspection Report

Date:	05/13/2018	Weather:		Coding:	RZMACP
MH#:	M-604-053	Owner:	NA	Len. Surveyed:	5.5
P.O.#:		Surveyor:	Jen Costello	Rim to Invert:	6.2
Customer:		Cert. #:	U-907-5518	Wall Material:	Concrete (reinforced)

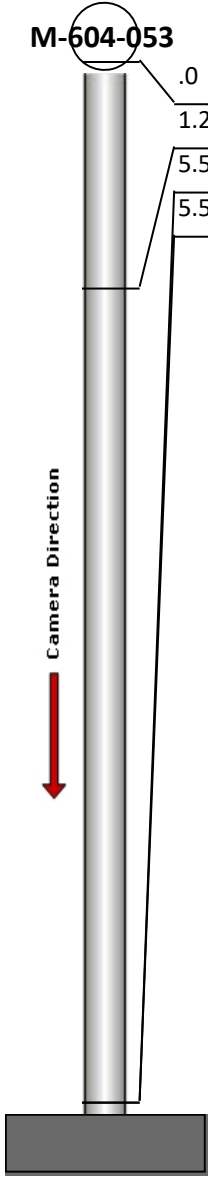
M-604-053				
	.0	MGP	General Photo	10	NA
	1.2	MGO	General Observation	26	NA
	5.5	DSF	Deposits Settled Fine	47	M 2
	5.5	MGO	General Observation	58	NA
