Manhole Inspection Report

Date:	04/29/2018	Weather:		Coding:	RZMACP
MH#:	M-604-064	Owner:	NA	Len. Surveyed:	3.7
P.O.#:		Surveyor:	Jen Costello	Rim to Invert:	4.3
Customer:		Cert. #:	U-907-5518	Wall Material:	Brick

Street:	Intersection of 1st St. and Pennsylv	Project:	Hobart, IN
City:	Hobart, IN	GPS Northing:	2902474.696
Location:		GPS Easting:	2902474.696
Drain Area:	West	GPS Accuracy:	Sub-Meter
Cover Shape:	Circular	Evidence of Surcharge:	No
Cover Size:	24.0	Potential for Runoff:	None
Comments:

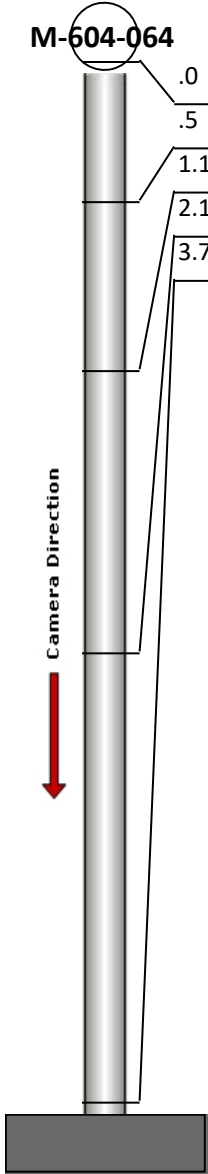
.0	MGP	General Photo	10	NA
	.5	DAE	Deposits Attached Encrustation	23	M 2
	1.1	MGO	General Observation	37	NA
	2.1	DSF	Deposits Settled Fine	52	M 2
	3.7	MGO	General Observation	67	NA
