Manhole Inspection Report

Date:	04/29/2018	Weather:		Coding:	RZMACP
MH#:	M-604-067	Owner:	NA	Len. Surveyed:	7.0
P.O.#:		Surveyor:	Jen Costello	Rim to Invert:	7.4
Customer:		Cert. #:	U-907-5518	Wall Material:	Brick

Street:	Intersection of Home Ave. and Penn	Project:	Hobart, IN
City:	Hobart, IN	GPS Northing:	2902467.311
Location:		GPS Easting:	2902467.311
Drain Area:	West	GPS Accuracy:	Sub-Meter
Cover Shape:	Circular	Evidence of Surcharge:	No
Cover Size:	24.0	Potential for Runoff:	None
Comments:

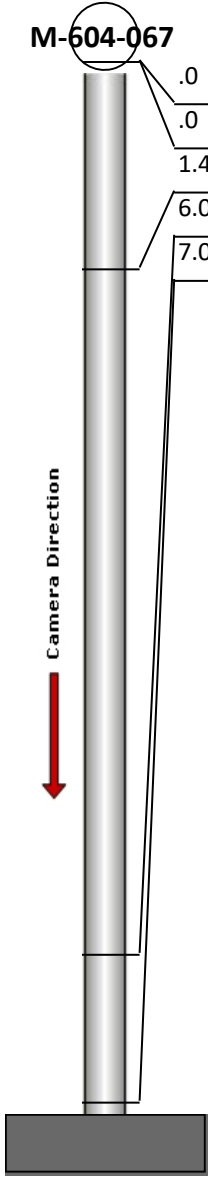
.0	MGP	General Photo	10	NA
	.0	DB	Displaced Brick	22	S 3
	1.4	MGO	General Observation	38	NA
	6.0	DSGV	Deposits Settled Gravel	61	M 2
	7.0	MGO	General Observation	75	NA
