# Manhole Inspection Report

Date:	05/13/2018	Weather:		Coding:	RZMACP
MH#:	M-604-095	Owner:	NA	Len. Surveyed:	9.2
P.O.#:		Surveyor:	Jen Costello	Rim to Invert:	9.8
Customer:		Cert. #:	U-907-5518	Wall Material:	Brick

Street:	Pennsylvania St. 528' North of Ridge	Project:	Hobart, IN
City:	Hobart, IN	GPS Northing:	2902334.901
Location:		GPS Easting:	2902334.901
Drain Area:	Northwest	GPS Accuracy:	Sub-Meter
Cover Shape:	Circular	Evidence of Surcharge:	No
Cover Size:	22.5	Potential for Runoff:	None
Comments:

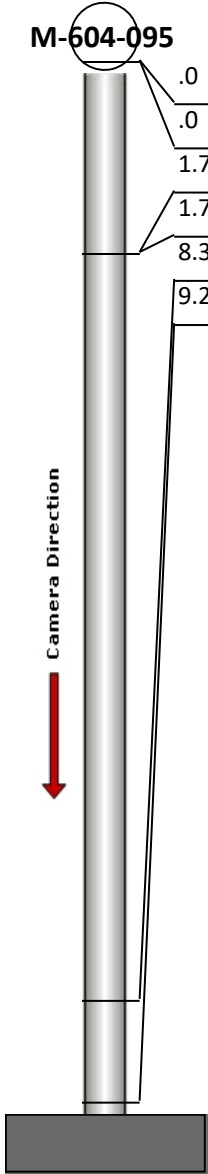
.0	MGP	General Photo	10	NA
	.0	FM	Fracture Multiple	20	S 4
	1.7	MGO	General Observation	37	NA
	1.7	SAV	Surface Aggregate Visible	50	S 3
	8.3	DSGV	Deposits Settled Gravel	75	M 2
	9.2	MGO	General Observation	88	NA
