# Manhole Inspection Report

Date:	05/14/2018	Weather:		Coding:	RZMACP
MH#:	M-604-100	Owner:	NA	Len. Surveyed:	8.0
P.O.#:		Surveyor:	Jen Costello	Rim to Invert:	8.2
Customer:		Cert. #:	U-907-5518	Wall Material:	Brick

Street:	163' East of Wisconsin St. 627' North	Project:	Hobart, IN
City:	Hobart, IN	GPS Northing:	2901964.478
Location:		GPS Easting:	2901964.478
Drain Area:	Northwest	GPS Accuracy:	Sub-Meter
Cover Shape:	Circular	Evidence of Surcharge:	No
Cover Size:	22.5	Potential for Runoff:	None
Comments:

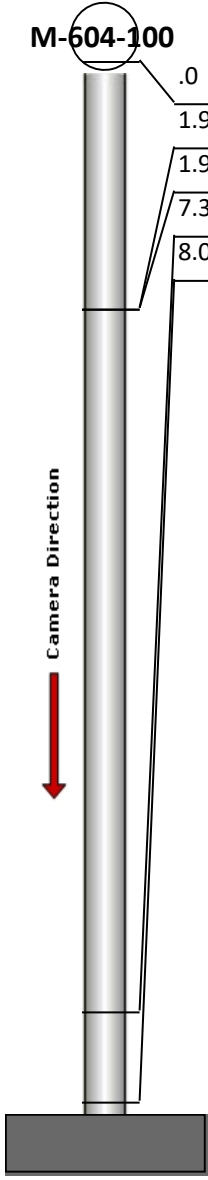
M-604-100				
	.0	MGP	General Photo	10	NA
	1.9	MGO	General Observation	28	NA
	1.9	SAV	Surface Aggregate Visible	39	S 3
	7.3	DSF	Deposits Settled Fine	63	M 2
	8.0	MGO	General Observation	76	NA
