Manhole Inspection Report

Date:	05/14/2018	Weather:		Coding:	RZMACP
MH#:	M-604-103	Owner:	NA	Len. Surveyed:	8.9
P.O.#:		Surveyor:	Jen Costello	Rim to Invert:	9.3
Customer:		Cert. #:	U-907-5518	Wall Material:	Brick

Street:	162' East of Wisconsin St. 158' South	Project:	Hobart, IN
City:	Hobart, IN	GPS Northing:	2901964.5
Location:		GPS Easting:	2901964.5
Drain Area:	Northwest	GPS Accuracy:	Sub-Meter
Cover Shape:	Circular	Evidence of Surcharge:	No
Cover Size:	22.5	Potential for Runoff:	None
Comments:

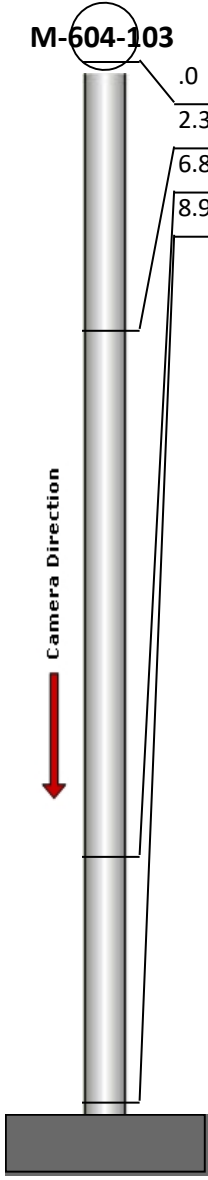
.0	MGP	General Photo	10	NA
	2.3	MGO	General Observation	29	NA
	6.8	OBR	Obstacle Rocks	51	M 2
	8.9	MGO	General Observation	67	NA
