# Manhole Inspection Report

Date:	<b>04/28/2018</b>	Weather:		Coding:	<b>RZMACP</b>
MH#:	<b>M-604-123</b>	Owner:	<b>NA</b>	Len. Surveyed:	<b>7.6</b>
P.O.#:		Surveyor:	<b>Jen Costello</b>	Rim to Invert:	<b>8.5</b>
Customer:		Cert. #:	<b>U-907-5518</b>	Wall Material:	<b>Brick</b>

Street:	<b>Old Ridge Road, and Beverly Blvd. T</b>	Project:	<b>Hobart, IN</b>
City:	<b>Hobart, IN</b>	GPS Northing:	<b>2904174.75</b>
Location:		GPS Easting:	<b>2904174.75</b>
Drain Area:	<b>Northwest</b>	GPS Accuracy:	<b>Sub-Meter</b>
Cover Shape:	<b>Circular</b>	Evidence of Surcharge:	<b>No</b>
Cover Size:	<b>22.5</b>	Potential for Runoff:	<b>None</b>
Comments:

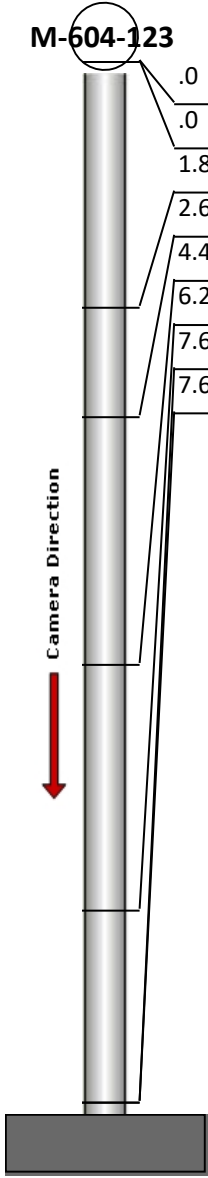
.0	FM	Fracture Multiple	10	S 4
	.0	MGO	General Observation	21	NA
	1.8	MGP	General Photo	39	NA
	2.6	SAV	Surface Aggregate Visible	54	S 3
	4.4	SSS	Surface Spalling	69	S 2
	6.2	DSF	Deposits Settled Fine	84	M 2
	7.6	DSF	Deposits Settled Fine	98	M 5
	7.6	MGO	General Observation	110	NA
