Manhole Inspection Report

Date:	05/01/2018	Weather:		Coding:	RZMACP
MH#:	M-605-006	Owner:	NA	Len. Surveyed:	6.5
P.O.#:		Surveyor:	Jen Costello	Rim to Invert:	6.4
Customer:		Cert. #:	U-907-5518	Wall Material:	Brick

Street:	Ellendale St. and 3rd St.	Project:	Hobart, IN
City:	Hobart, IN	GPS Northing:	41.53201675
Location:		GPS Easting:	-87.26200104
Drain Area:	West	GPS Accuracy:	Nearest Meter
Cover Shape:	Circular	Evidence of Surcharge:	No
Cover Size:	22.5	Potential for Runoff:	None
Comments:

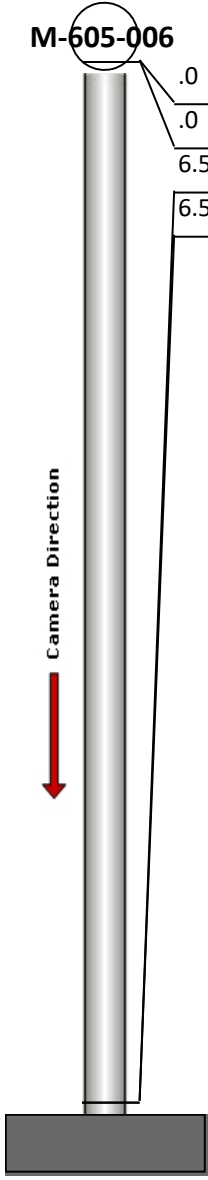
M-605-006				
	.0	MGP	General Photo	10	NA
	.0	B	Broken	22	S 5
	6.5	DSF	Deposits Settled Fine	46	M 3
	6.5	MGO	General Observation	57	NA
