Manhole Inspection Report

Date:	05/01/2018	Weather:		Coding:	RZMACP
MH#:	M-605-010	Owner:	NA	Len. Surveyed:	7.8
P.O.#:		Surveyor:	Jen Costello	Rim to Invert:	8.5
Customer:		Cert. #:	U-907-5518	Wall Material:	Brick

Street:	Intersection of Pennsylvania St. and	Project:	Hobart, IN
City:	Hobart, IN	GPS Northing:	41.53255081
Location:		GPS Easting:	-87.266922
Drain Area:	West	GPS Accuracy:	Nearest Meter
Cover Shape:	Circular	Evidence of Surcharge:	No
Cover Size:	22.5	Potential for Runoff:	None
Comments:

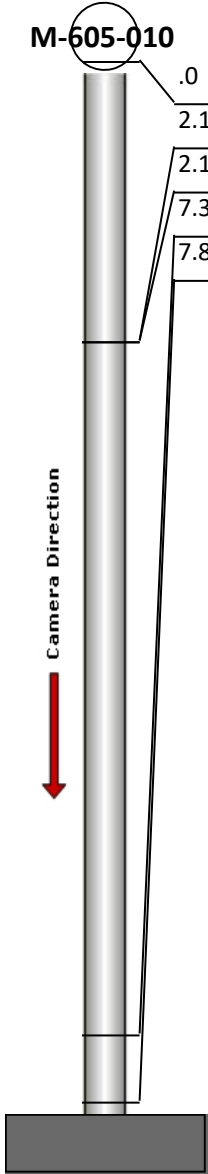
M-605-010				
	.0	MGP	General Photo	10	NA
	2.1	DB	Displaced Brick	26	S 3
	2.1	MGO	General Observation	39	NA
	7.3	OBR	Obstacle Rocks	63	M 2
	7.8	MGO	General Observation	75	NA
