Manhole Inspection Report

Date:	05/01/2018	Weather:		Coding:	RZMACP
MH#:	M-605-013	Owner:	NA	Len. Surveyed:	10.2
P.O.#:		Surveyor:	Jen Costello	Rim to Invert:	10.6
Customer:		Cert. #:	U-907-5518	Wall Material:	Brick

Street:	Intersection of Ellendale St. and Cou	Project:	Hobart, IN
City:	Hobart, IN	GPS Northing:	41.53304672
Location:		GPS Easting:	-87.26202393
Drain Area:	West	GPS Accuracy:	Nearest Meter
Cover Shape:	Circular	Evidence of Surcharge:	No
Cover Size:	22.5	Potential for Runoff:	None
Comments:

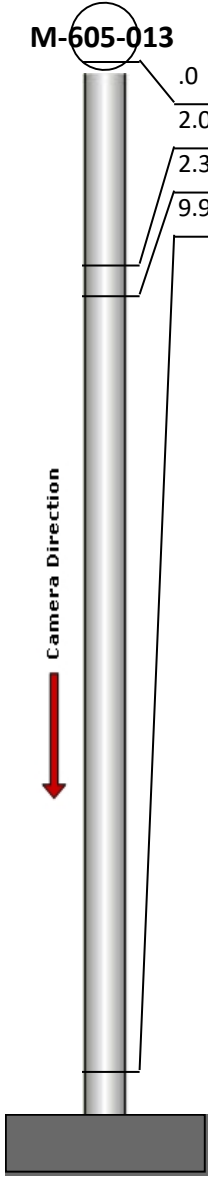
.0	MGP	General Photo	10	NA
	2.0	MGO	General Observation	28	NA
	2.3	FM	Fracture Multiple	44	S 4
	9.9	MGO	General Observation	73	NA
