Manhole Inspection Report

Date:	04/29/2018	Weather:		Coding:	RZMACP
MH#:	M-605-032	Owner:	NA	Len. Surveyed:	7.4
P.O.#:		Surveyor:	Jen Costello	Rim to Invert:	7.8
Customer:		Cert. #:	U-907-5518	Wall Material:	Brick

Street:	Connecticut St. 2nd St.	Project:	Hobart, IN
City:	Hobart, IN	GPS Northing:	2902820.644
Location:		GPS Easting:	2902820.644
Drain Area:	West	GPS Accuracy:	Sub-Meter
Cover Shape:	Circular	Evidence of Surcharge:	No
Cover Size:	22.5	Potential for Runoff:	None
Comments:

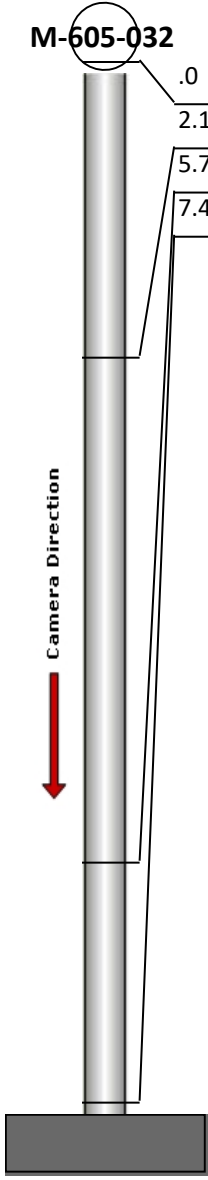
Position	Code	Observation	Video (sec)	Grade

.0	MGO	General Observation	10	NA
	2.1	MGO	General Observation	28	NA
	5.7	DSF	Deposits Settled Fine	49	M 2
	7.4	MGO	General Observation	63	NA
