Manhole Inspection Report

Date:	04/29/2018	Weather:		Coding:	RZMACP
MH#:	M-605-039	Owner:	NA	Len. Surveyed:	4.6
P.O.#:		Surveyor:	Jen Costello	Rim to Invert:	4.6
Customer:		Cert. #:	U-907-5518	Wall Material:	Brick

Street:	Pennsylvania St. 220' North of 2nd S	Project:	Hobart, IN
City:	Hobart, IN	GPS Northing:	2902487.339
Location:		GPS Easting:	2902487.339
Drain Area:	West	GPS Accuracy:	Sub-Meter
Cover Shape:	Circular	Evidence of Surcharge:	No
Cover Size:	24.0	Potential for Runoff:	None
Comments:

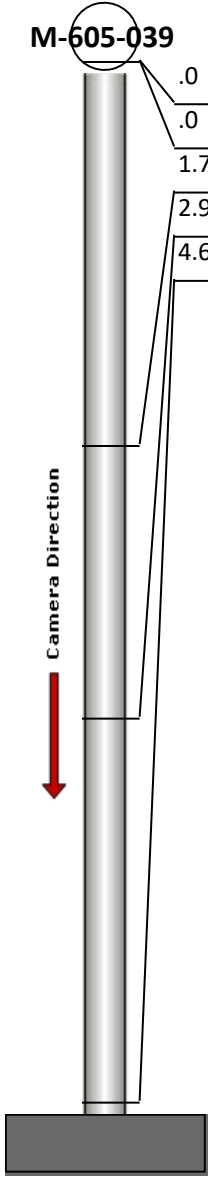
.0	MGP	General Photo	10	NA
	.0	SAV	Surface Aggregate Visible	21	S 3
	1.7	MGP	General Photo	38	NA
	2.9	DSGV	Deposits Settled Gravel	54	M 2
	4.6	MGO	General Observation	69	NA
