Manhole Inspection Report

Date:	04/29/2018	Weather:		Coding:	RZMACP
MH#:	M-605-040	Owner:	NA	Len. Surveyed:	3.3
P.O.#:		Surveyor:	Jen Costello	Rim to Invert:	4.1
Customer:		Cert. #:	U-907-5518	Wall Material:	Brick

Street:	Pennsylvania St. 226' South of 1st St	Project:	Hobart, IN
City:	Hobart, IN	GPS Northing:	2902483.017
Location:		GPS Easting:	2902483.017
Drain Area:	West	GPS Accuracy:	Sub-Meter
Cover Shape:	Circular	Evidence of Surcharge:	No
Cover Size:	24.0	Potential for Runoff:	None
Comments:

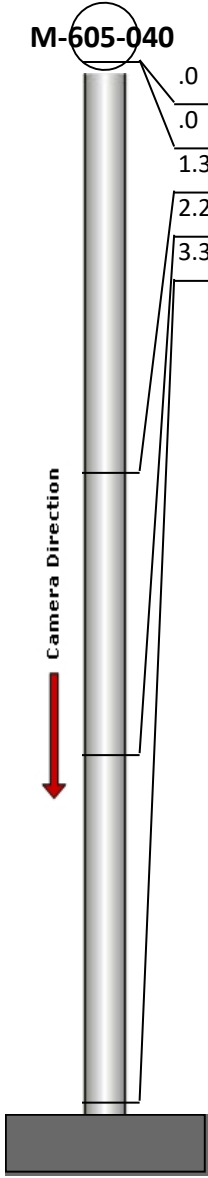
.0	MGO	General Observation	10	NA
	.0	SAV	Surface Aggregate Visible	22	S 3
	1.3	MGO	General Observation	38	NA
	2.2	DSF	Deposits Settled Fine	53	M 2
	3.3	MGO	General Observation	66	NA
