Manhole Inspection Report

Date:	04/29/2018	Weather:		Coding:	RZMACP
MH#:	M-605-043	Owner:	NA	Len. Surveyed:	7.3
P.O.#:		Surveyor:	Jen Costello	Rim to Invert:	7.8
Customer:		Cert. #:	U-907-5518	Wall Material:	Brick

Street:	Washington St. 261' South of 2nd St.	Project:	Hobart, IN
City:	Hobart, IN	GPS Northing:	2902163.327
Location:		GPS Easting:	2902163.327
Drain Area:	West	GPS Accuracy:	Sub-Meter
Cover Shape:	Circular	Evidence of Surcharge:	No
Cover Size:	22.5	Potential for Runoff:	None
Comments:

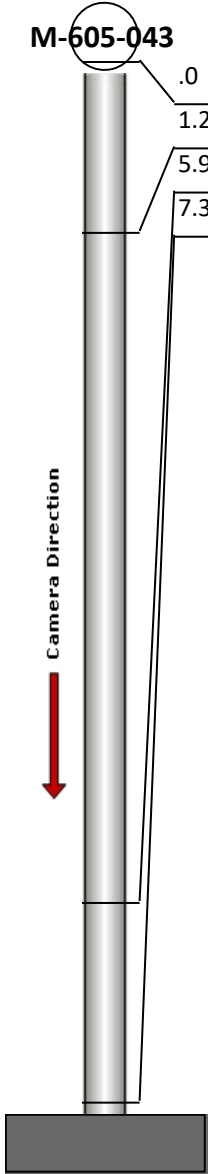
M-605-043				
	.0	MGP	General Photo	10	NA
	1.2	MGO	General Observation	25	NA
	5.9	DSF	Deposits Settled Fine	48	M 2
	7.3	MGO	General Observation	62	NA
