Manhole Inspection Report

Date:	04/29/2018	Weather:		Coding:	RZMACP
MH#:	M-605-044	Owner:	NA	Len. Surveyed:	7.0
P.O.#:		Surveyor:	Jen Costello	Rim to Invert:	7.6
Customer:		Cert. #:	U-907-5518	Wall Material:	Brick

Street:	Intersection of 2nd St. and Washingt	Project:	Hobart, IN
City:	Hobart, IN	GPS Northing:	2902168.003
Location:		GPS Easting:	2902168.003
Drain Area:	West	GPS Accuracy:	Sub-Meter
Cover Shape:	Circular	Evidence of Surcharge:	No
Cover Size:	22.5	Potential for Runoff:	None
Comments:

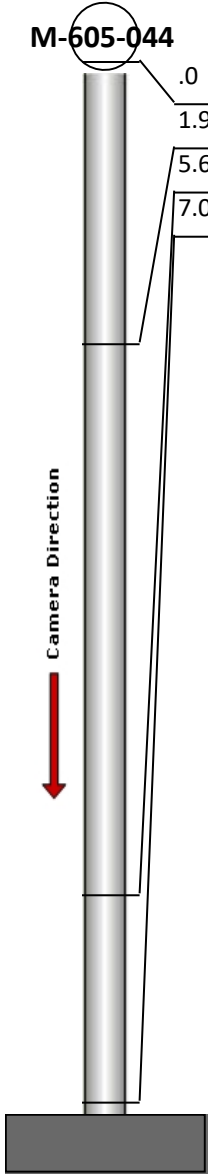
.0	MGP	General Photo	10	NA
	1.9	MGO	General Observation	28	NA
	5.6	DSF	Deposits Settled Fine	49	M 2
	7.0	MGO	General Observation	63	NA
