Manhole Inspection Report

Date:	04/29/2018	Weather:		Coding:	RZMACP
MH#:	M-605-046	Owner:	NA	Len. Surveyed:	7.6
P.O.#:		Surveyor:	Jen Costello	Rim to Invert:	8.1
Customer:		Cert. #:	U-907-5518	Wall Material:	Brick

Street:	Washington St. 227' South of 1st St.	Project:	Hobart, IN
City:	Hobart, IN	GPS Northing:	2902145.769
Location:		GPS Easting:	2902145.769
Drain Area:	West	GPS Accuracy:	Sub-Meter
Cover Shape:	Circular	Evidence of Surcharge:	No
Cover Size:	22.5	Potential for Runoff:	None
Comments:

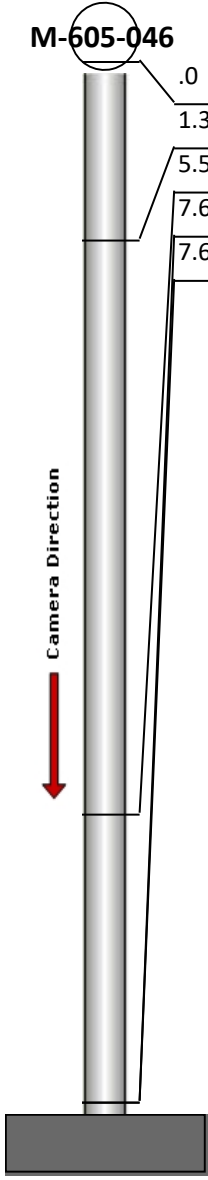
.0	MGP	General Photo	10	NA
	1.3	MGO	General Observation	26	NA
	5.5	DSZ	Deposits Settled Other	47	M 2
	7.6	RMJ	Roots Medium Joint	63	M 3
	7.6	MGO	General Observation	75	NA
