Manhole Inspection Report

Date:	05/02/2018	Weather:		Coding:	RZMACP
MH#:	M-605-048	Owner:	NA	Len. Surveyed:	9.3
P.O.#:		Surveyor:	Jen Costello	Rim to Invert:	10.2
Customer:		Cert. #:	U-907-5518	Wall Material:	Brick

Street:	Wisconsin St. 245' North of 3rd St.	Project:	Hobart, IN
City:	Hobart, IN	GPS Northing:	41.53331375
Location:		GPS Easting:	-87.26930237
Drain Area:	West	GPS Accuracy:	Nearest Meter
Cover Shape:	Circular	Evidence of Surcharge:	No
Cover Size:	22.5	Potential for Runoff:	None
Comments:

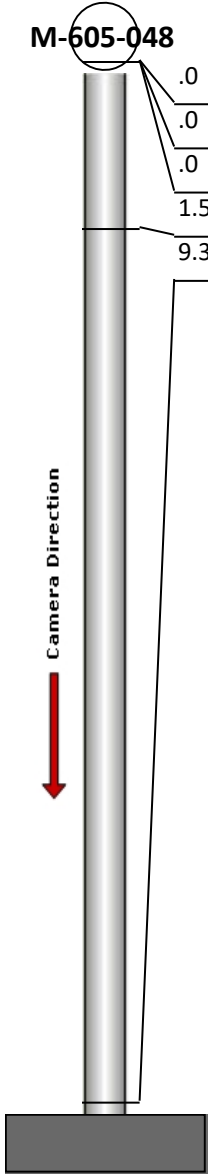
M-605-048				
	.0	MGP	General Photo	10	NA
	.0	DAE	Deposits Attached Encrustation	21	M 2
	.0	DB	Displaced Brick	31	S 3
	1.5	MGO	General Observation	47	NA
	9.3	MGO	General Observation	76	NA
