Manhole Inspection Report

Date:	04/30/2018	Weather:		Coding:	RZMACP
MH#:	M-605-050	Owner:	NA	Len. Surveyed:	11.1
P.O.#:		Surveyor:	Jen Costello	Rim to Invert:	11.6
Customer:		Cert. #:	U-907-5518	Wall Material:	Brick

Street:	Intersection of Wisconsin St. and 2n	Project:	Hobart, IN
City:	Hobart, IN	GPS Northing:	41.53458786
Location:		GPS Easting:	-87.26932526
Drain Area:	West	GPS Accuracy:	Nearest Meter
Cover Shape:	Circular	Evidence of Surcharge:	No
Cover Size:	22.5	Potential for Runoff:	None
Comments:

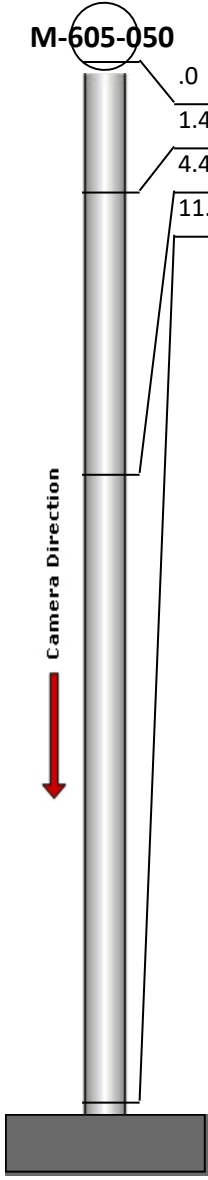
.0	MGO	General Observation	10	NA
	1.4	MGO	General Observation	26	NA
	4.4	IW	Infil Weeper	45	M 2
	11.1	MGO	General Observation	70	NA
