Manhole Inspection Report

Date:	04/26/2018	Weather:		Coding:	RZMACP
MH#:	M-606-004	Owner:	NA	Len. Surveyed:	12.2
P.O.#:		Surveyor:	Jen Costello	Rim to Invert:	12.1
Customer:		Cert. #:	U-907-5518	Wall Material:	Concrete (reinforced)

Street:	Lake Park Ave. 631' South of 8th St.	Project:	Hobart, IN
City:	Hobart, IN	GPS Northing:	2904529.19
Location:		GPS Easting:	2904529.19
Drain Area:	Southeast	GPS Accuracy:	Sub-Meter
Cover Shape:	Circular	Evidence of Surcharge:	No
Cover Size:	22.5	Potential for Runoff:	None
Comments:

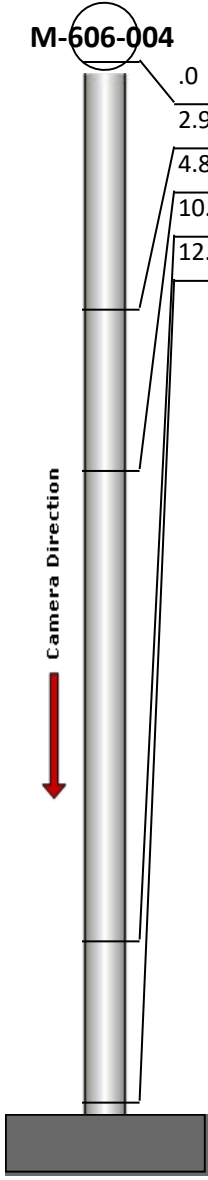
.0	MGO	General Observation	10	NA
	2.9	MGO	General Observation	30	NA
	4.8	IS	Infil Stain	47	NA
	10.3	DSGV	Deposits Settled Gravel	69	M 2
	12.2	MGO	General Observation	85	NA
