Manhole Inspection Report

Date:	04/24/2018	Weather:		Coding:	RZMACP
MH#:	M-606-012	Owner:	NA	Len. Surveyed:	10.5
P.O.#:		Surveyor:	John Kuglmaier	Rim to Invert:	10.6
Customer:	8.7	Cert. #:	U-1215-07002349	Wall Material:	Concrete (reinforced)

Street:	8th Pl. 478' South of 8th St.	Project:	Hobart, IN
City:	Hobart, IN	GPS Northing:	0.0
Location:		GPS Easting:	0.0
Drain Area:	Southwest	GPS Accuracy:	Nearest Meter
Cover Shape:	Circular	Evidence of Surcharge:	No
Cover Size:	22.5	Potential for Runoff:	None
Comments:

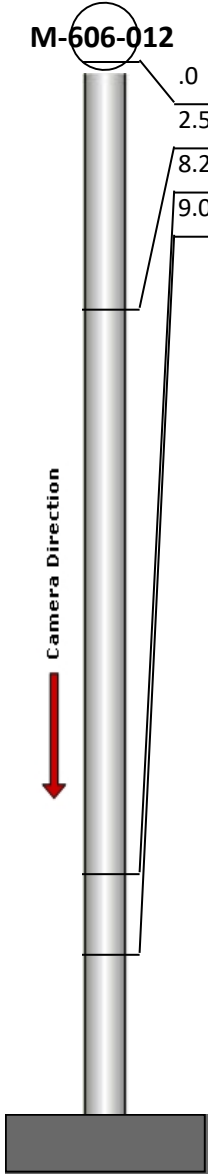
M-606-012				
	.0	MGP	General Photo	10	NA
	2.5	MGP	General Photo	29	NA
	8.2	DAZ	Deposits Attached Other	54	M 2
	9.0	MGO	General Observation	67	NA
