Manhole Inspection Report

Date:	04/26/2018	Weather:		Coding:	RZMACP
MH#:	M-606-028	Owner:	NA	Len. Surveyed:	13.6
P.O.#:		Surveyor:	Jen Costello	Rim to Invert:	.0
Customer:		Cert. #:	U-907-5518	Wall Material:	Concrete (reinforced)

Street:	Lake Park Ave. 264' North of 10th St.	Project:	Hobart, IN
City:	Hobart, IN	GPS Northing:	0.0
Location:		GPS Easting:	0.0
Drain Area:	Southeast	GPS Accuracy:	Nearest Meter
Cover Shape:	Circular	Evidence of Surcharge:	No
Cover Size:	22.5	Potential for Runoff:	None
Comments:

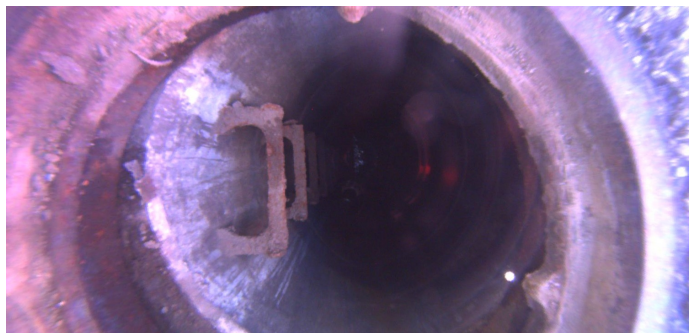
Code: **MGO**
Description: **General Observation**

Distance (ft): **.0**
Structural Grade: **0**
O&M Grade: **0**
Clock Start/From:
Clock To:
1st Value:
2nd Value:
Value Percent:
Step: **NO**
Remarks: **ACCESS MH**

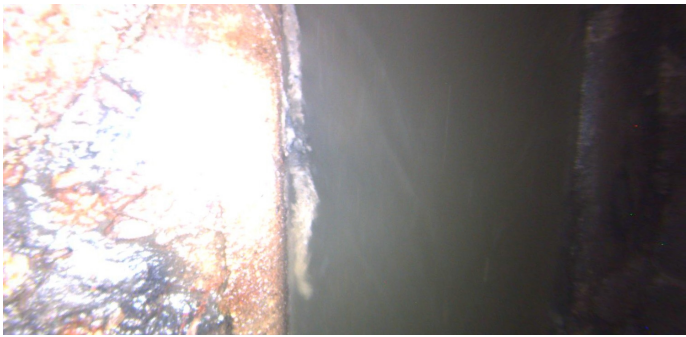
Code: **MGO**
Description: **General Observation**

Distance (ft): **13.6**
Structural Grade: **0**
O&M Grade: **0**
Clock Start/From:
Clock To:
1st Value:
2nd Value:
Value Percent:
Step: **NO**
Remarks: **END SURVEY**
