Manhole Inspection Report

Date:	04/26/2018	Weather:		Coding:	RZMACP
MH#:	M-606-054	Owner:	NA	Len. Surveyed:	7.7
P.O.#:		Surveyor:	Jen Costello	Rim to Invert:	8.1
Customer:		Cert. #:	U-907-5518	Wall Material:	Concrete (reinforced)

Street:	Riverside Dr. 186' North of Lagoon A	Project:	Hobart, IN
City:	Hobart, IN	GPS Northing:	2903082.466
Location:		GPS Easting:	2903082.466
Drain Area:	Southwest	GPS Accuracy:	Sub-Meter
Cover Shape:	Circular	Evidence of Surcharge:	No
Cover Size:	22.5	Potential for Runoff:	None
Comments:

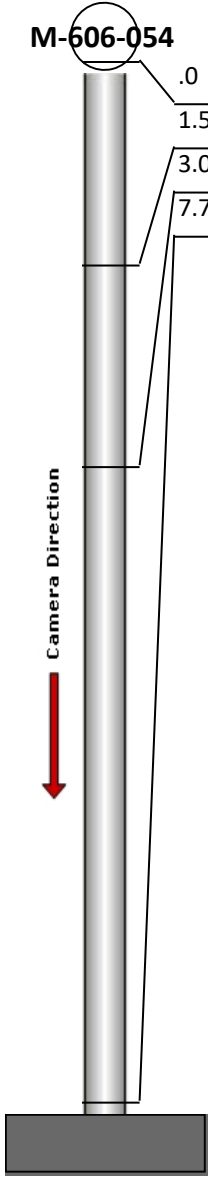
.0	MGO	General Observation	10	NA
	1.5	MGO	General Observation	26	NA
	3.0	IW	Infil Weeper	43	M 2
	7.7	MGO	General Observation	64	NA
