Manhole Inspection Report

Date:	09/28/2022	Weather:		Coding:	RZMACP
MH#:	M-606-058	Owner:	NA	Len. Surveyed:	17.6
P.O.#:		Surveyor:	Jen Costello	Rim to Invert:	19.4
Customer:		Cert. #:	U-907-5518	Wall Material:	Concrete (cast in place)

Street:	8th St. 168' East of Wisconsin St.	Project:	Hobart, IN
City:	Hobart, IN	GPS Northing:	2286498.222
Location:	Yard	GPS Easting:	2902034.898
Drain Area:	Southwest	GPS Accuracy:	Sub-Meter
Cover Shape:	Circular	Evidence of Surcharge:	No
Cover Size:	24.0	Potential for Runoff:	None
Comments:

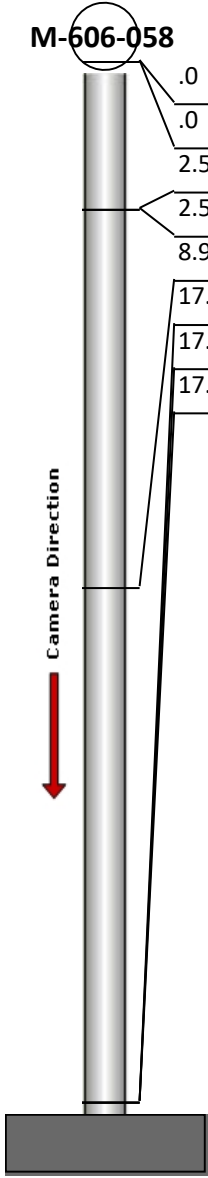
M-606-058				
	.0	MGO	General Observation	10	NA
	.0	SRI	Surface Roughness Increased	21	S 1
	2.5	FM	Fracture Multiple	40	S 4
	2.5	MGO	General Observation	51	NA
	8.9	RPP	Repair Patch	78	NA
	17.6	DSGV	Deposits Settled Gravel	107	M 2
	17.6	SRI	Surface Roughness Increased	118	S 1
	17.6	MGO	General Observation	129	NA
