Manhole Inspection Report

Date:	04/26/2018	Weather:		Coding:	RZMACP
MH#:	M-606-074	Owner:	NA	Len. Surveyed:	14.5
P.O.#:		Surveyor:	Jen Costello	Rim to Invert:	15.1
Customer:		Cert. #:	U-907-5518	Wall Material:	Concrete (reinforced)

Street:	155' North of 7th St. and East of Holl	Project:	Hobart, IN
City:	Hobart, IN	GPS Northing:	2903017.305
Location:		GPS Easting:	2903017.305
Drain Area:	Southwest	GPS Accuracy:	Sub-Meter
Cover Shape:	Circular	Evidence of Surcharge:	No
Cover Size:	22.5	Potential for Runoff:	None
Comments:

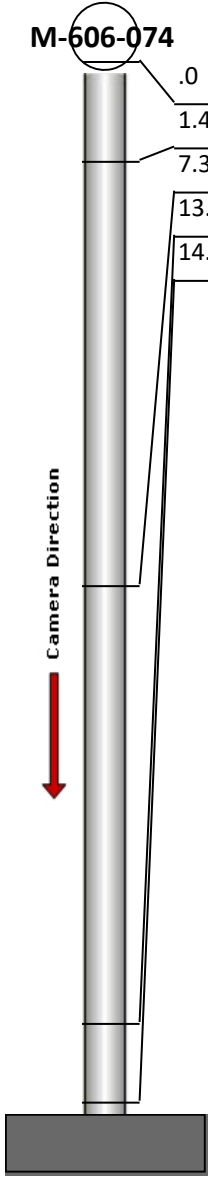
.0	MGO	General Observation	10	NA
	1.4	MGP	General Photo	26	NA
	7.3	IS	Infil Stain	51	NA
	13.4	DSF	Deposits Settled Fine	75	M 2
	14.5	MGO	General Observation	89	NA
